## 4. Land Quality

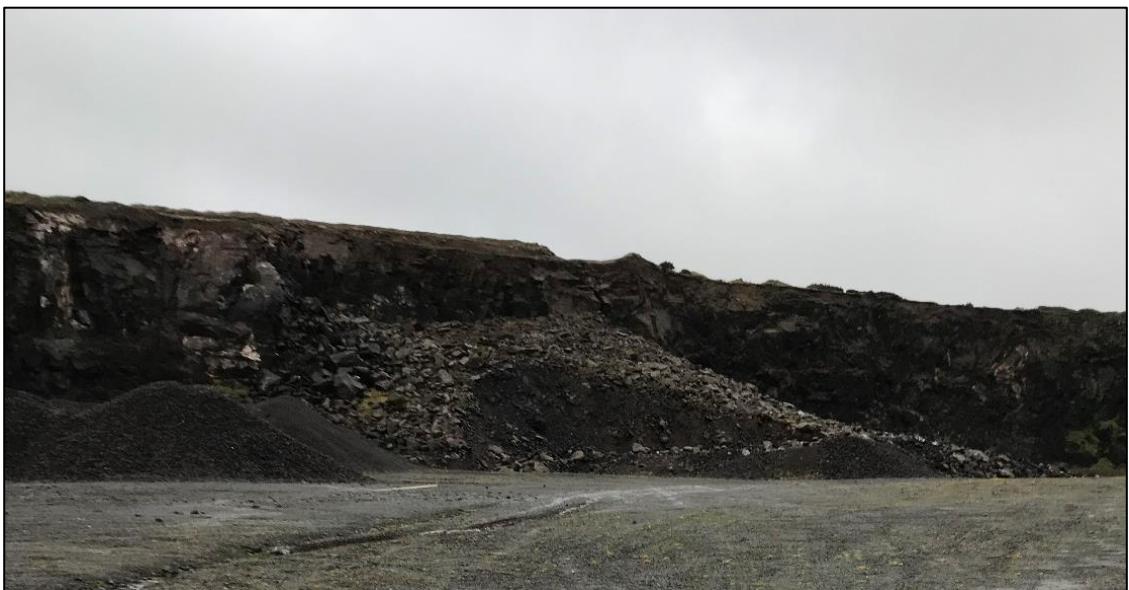
- 4.11 During the site walkover it was noted that blasting activity had occurred on two occasions since the last site visit. The first of these was carried out along the southern rockface in the upper platform of the site. This was to provide granular material for use on site, which was then piled in the upper yard as evidenced in Figure 4.1 below.

**Figure 4.1 Evidence of the larger blast carried out on the southern rockface in the upper platform**

- 4.13 The site walkover confirmed that there were no signs of contamination from historic or recent blasting activities.
- 4.14 The site representative also indicated that the abandoned building to the North of the banded fuel tanks, as evidenced in Figure 4.2, had been confirmed to have asbestos containing materials within the roof. However, it was discussed that this building was to be retained as it is an existing bat roost and is not situated within the construction site boundary.

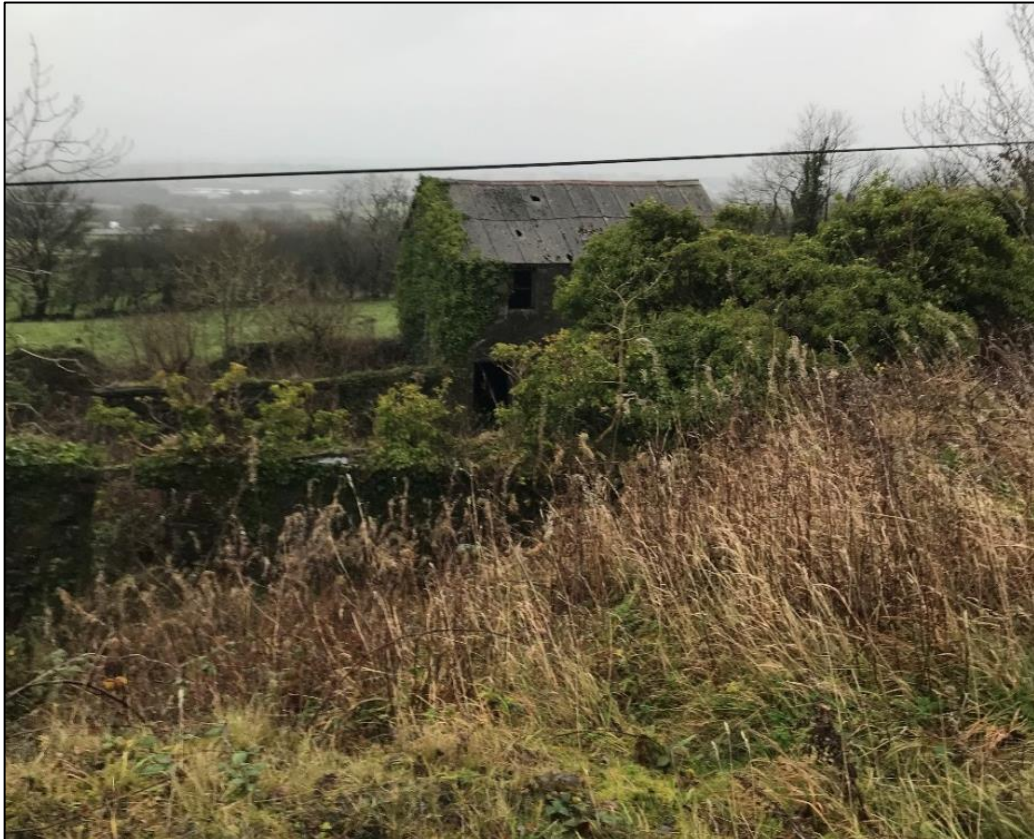
**Figure 4.2 Abandoned building with asbestos containing materials in roof now used as a bat roost**
