## 4. Land Quality

- 4.1 The principle aim of this chapter is to identify any additional information on Land Quality that requires consideration since the original EIA submission (March 2014) and the previous EIA addendums (September 2014 and March 2019).

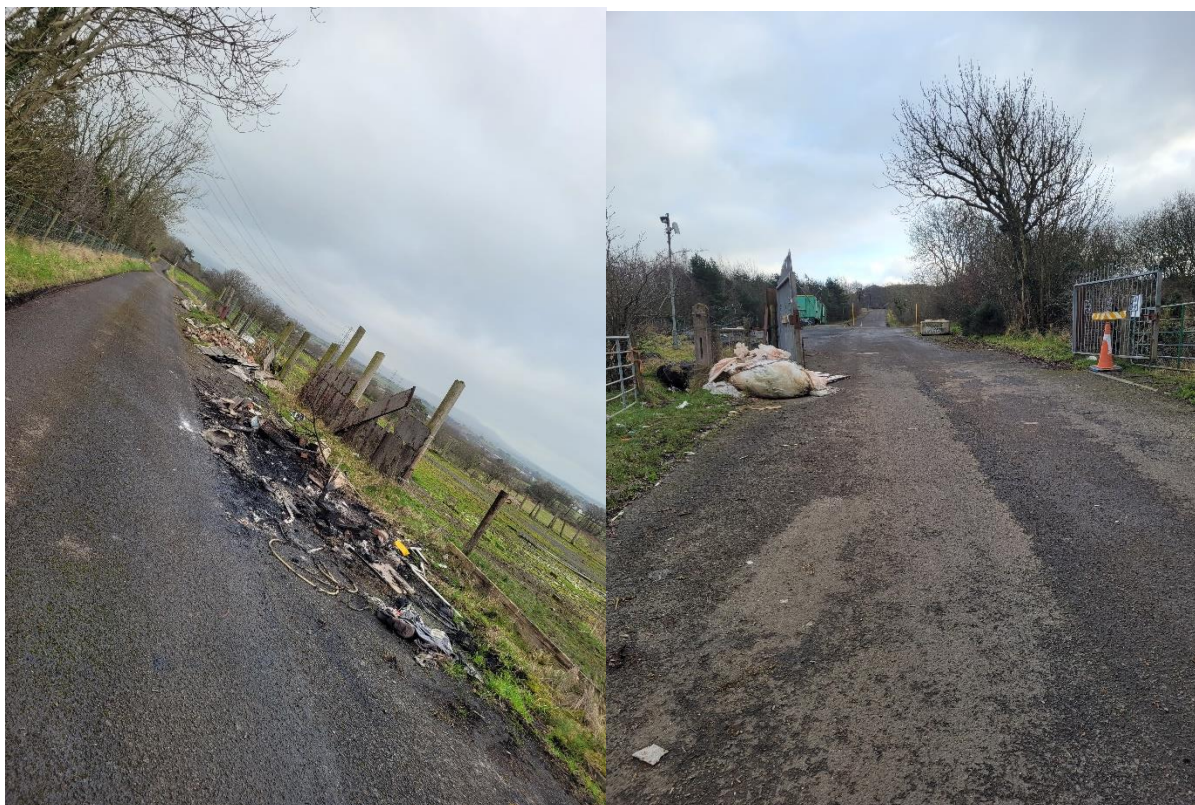
- 4.13 During the site walkover (09/02/2023) it was noted that little had changed at the site since the 2018 site visit. Fly tipping was noted to have occurred along the access road entering the site and in the northern area of the main development as evidenced in Figure 4.1.

**Figure 4.1 Evidence of Fly Tipping**

| Potential Source and Reason for Concern | Potential Pathway(s) to Receptor | Potential Receptor | Preliminary Risk Assessment and Mitigation of Relevant Source-Pathway-Linkage | Is further investigation required? |
|--|--|---|--|--|
| Fly Tipping | Physical Risk | Road users, site construction workers, site users, site visitors. | Nil to Tolerable risk – no obvious evidence of ground contamination but represents a physical hazard | No further investigation is recommended, however material should be removed and disposed of at earliest convenience to minimise any physical hazards. |

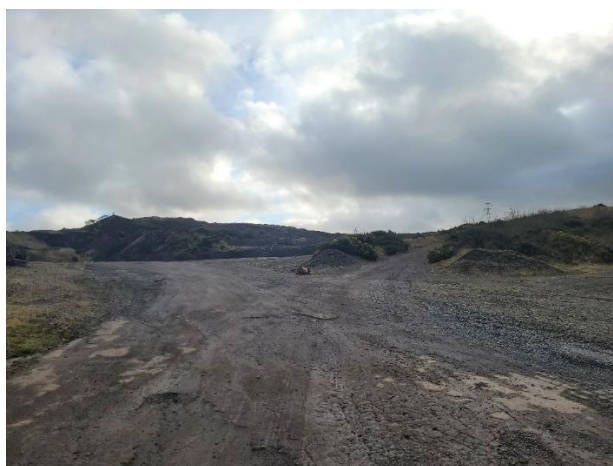
4.14 Within the centre of the site road planings have been stored as evidenced in Figure 4.2 and a derelict building contained evidence of chemical spills as evidenced in Figure 4.3. The road planings are for use in highway aggregate and have been classified as recycled material for this use. These road planings are therefore not considered to be a contamination risk.

**Figure 4.2 Storage of Road Planings**

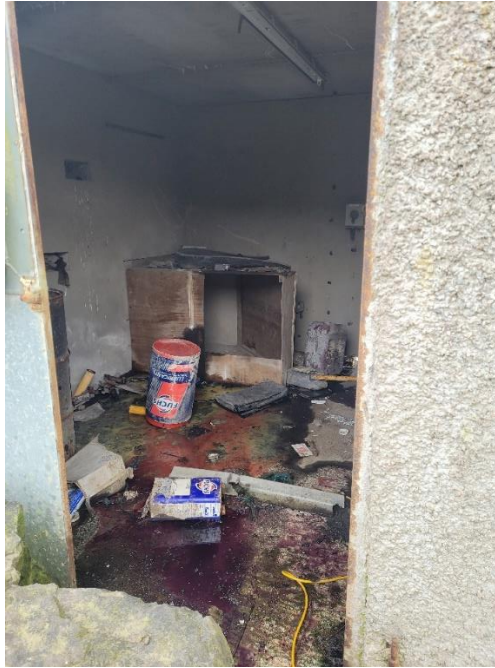
**Figure 4.3 Derelict Building Containing Potential Chemical Spills**

| Potential Source and Reason for Concern | Potential Pathway(s) to Receptor | Potential Receptor | Preliminary Risk Assessment and Mitigation of Relevant Source-Pathway-Linkage | Is further investigation required? |
|--|--|---|--|--|
| Derelict Building Containing potential chemical spills | Contact with, inhalation or ingestion of materials | Road users, site construction workers, site users, site visitors. | Nil to Tolerable risk – Site management aware of this and in process of remedying. | No further investigation is recommended, however material should be removed and disposed of at earliest convenience to minimise any potential hazards. |
| | Fissure in Rock. | Groundwater | Nil to Tolerable risk – No spillages were observed outside building. Concrete slab/ floor is intact. | No further investigation is recommended, however material should be removed and disposed of at earliest convenience to minimise any potential hazards. |
