Chapter 8 Land Quality

arc21 Residual Waste Treatment Project: Hightown Quarry

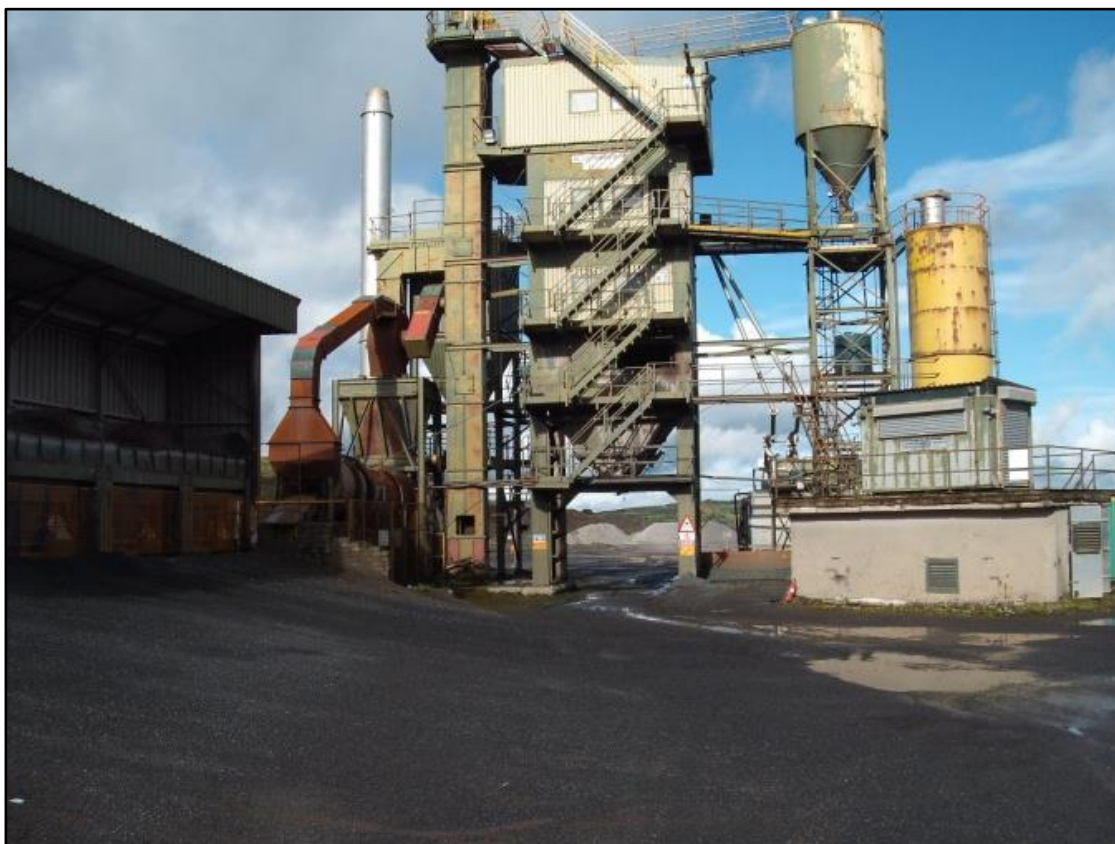
Fig 8.1 Decommissioned Asphalt Plant

- 8.24 The area of the former asphalt plant is flat and pools of standing water were observed. Dust and sand stores are located adjacent to the former asphalt plant and were used in the asphalt process. The area of the now decommissioned asphalt plant is shown in Figure 8.1.

- 8.23 Formerly located to the east of the quarry within the application site is a recently decommissioned asphalt plant and associated fuel and bitumen tanks. Three bitumen tanks were located in this area, each with a 10,000 gallon capacity. There were localised signs of bitumen spillage during site visits and inspections. The fuel tanks included a gas oil tank (capacity 50,000 litres) and a plastic fuel tank (circa 2000 litres). These fuel tanks were bunded and no spillages were observed.

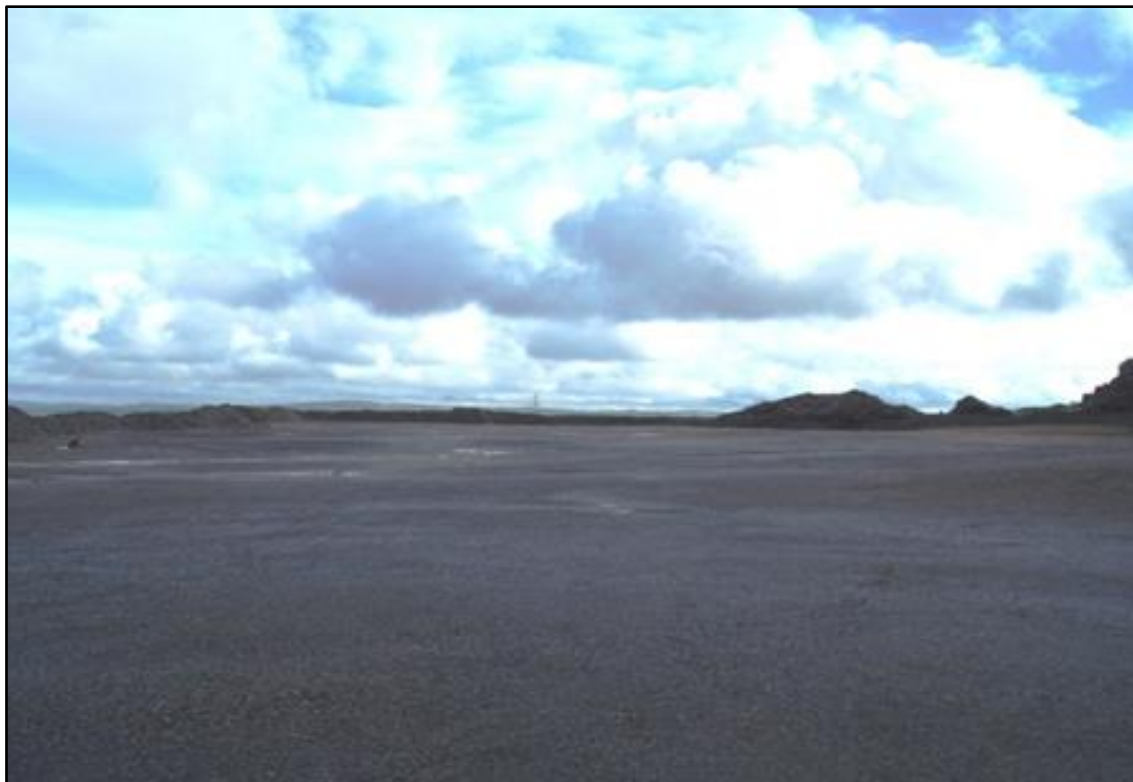
Fig 8.2 Upper Platform

- 8.28 The operational component of the application is located within the southern section of the quarry. This section of the site is known as the Upper Yard and is divided by two broad benches that are cut into the rock with platform elevations of 244 mOD and 260 mOD. A typical view of the upper platform is displayed in Figure 8.2.

- 8.29 A layer of fine gravel and fine sand/silt overlays the rock. This layer was observed as being very thin in the region of 25-50mm. Exposed rock was also observed throughout the application site.
- 8.30 During the site visit a number of pools of standing water were observed (see Figure 8.3) on the surface of the application site indicating a relatively impervious surface, though that may in part be due to infilling of fractures within the bedrock by quarry rock dust. It was confirmed with the quarry operators that the source of this water is rainfall and not an artesian source.
